## Asbestos-Containing Building Material

### Demolition Survey Report

#### Project 9462AS

#### Fishguard Primary School, Brodog Lane, Fishguard.

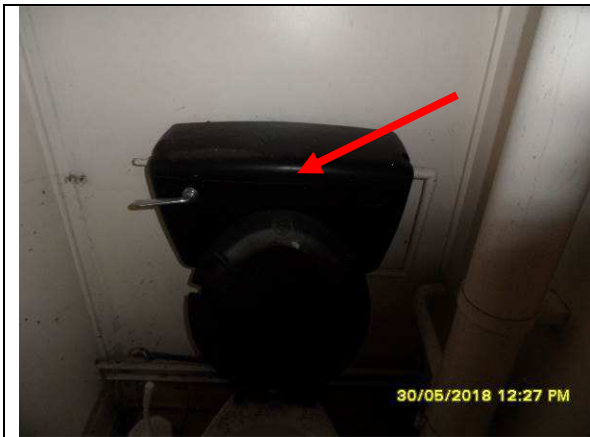
9462AS – 001

Last date ACM inspected	Last date ACM modified	Note	Licensed work?
A			PHH62-02-1	9462AS-001	G04	Wall mounted	Toilet cistern	Reinforced plastic and resin composites	Positive asbestos sample	1No	NA	1	0	2	4	NA	NA	Remove	30/05/18			No
A			PHH62-02-2	9462AS-002	G04	Flue from burner through roof	Flue pipe	Cement - Pre-formed moulded or extruded products	Positive asbestos sample	2LM	NA	1	1	1	4	NA	NA	Remove	30/05/18			No*

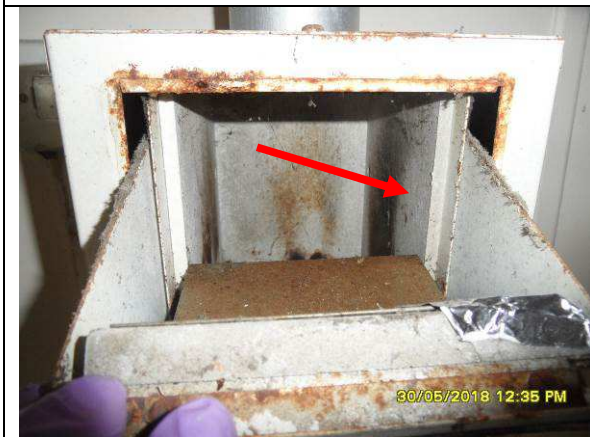
9462AS – 003

A			PHH62-02-3	9462AS-003	G04	Bunny burner internals	Lining board	Cement - Fully comp flat sheet, tiles, slates & boards	Positive asbestos sample	1No	NA	1	1	1	4	NA	NA	Remove	30/05/18			No*
A			PHH62-02-5	9462AS-006	G07	Floor covering	Beige tiles and adhesive	PVC vinyl flooring and adhesive	Positive asbestos sample	16SM	NA	1	0	1	3	NA	NA	Remove	30/05/18			No
A			PHH62-02-6	9462AS-007	G07	Switch box internals	Flashguards	Textiles - Cloth	Positive asbestos sample	Small Quants	NA	0	0	1	3	NA	NA	Remove	30/05/18		To two 'BILL' switch boxes	No
A			PHH62-02-7	9462AS-008	G01	Boxing to ceiling extractor fan	Lining board	Insulating board	Positive asbestos sample	4No	NA	0	1	2	5	NA	NA	Remove	30/05/18		Four panels	Yes
A			PHH62-02-8	9462AS-009	G01	Ceiling	Lining board	Insulating board	Positive asbestos sample	38SM	NA	0	2	2	6	NA	NA	Remove	30/05/18			Yes
A			PHH62-02-9	9462AS-010	G09, G14 and G19	Floor covering	Beige tiles and adhesive	PVC vinyl flooring and adhesive	Positive asbestos sample	22SM	NA	0	0	1	2	NA	NA	Remove	30/05/18		Tiles contaminated by adhesive	No

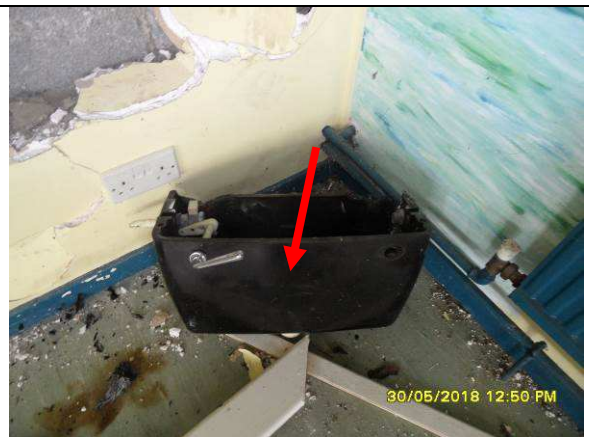
9462AS – 005

B	9462 AS-001			9462AS-005	G05	Loose on floor	Toilet cistern	Reinforced plastic and resin composites	Strong presumption (extrapolation)	1No	NA	1	0	1	3	NA	NA	Remove	30/05/18		Tiles contaminated by adhesive	No
B	9462 AS-010			9462AS-012	G08	Floor covering	Beige tiles and adhesive	PVC vinyl flooring and adhesive	Strong presumption (extrapolation)	9SM	NA	0	0	1	2	NA	NA	Remove	30/05/18		Tiles contaminated by adhesive	No

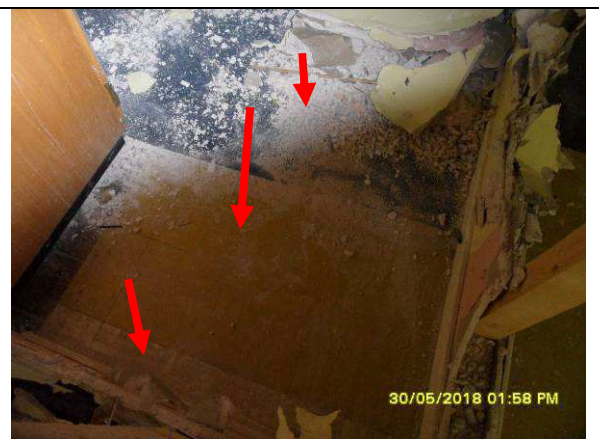
9462AS – 013

Recommendation	Last date ACM inspected	Last date ACM modified	Note	Licensed work?
B	9462 AS-011			9462AS-013	G15	Floor covering	Black/yellow/white tiles and adhesive	PVC vinyl flooring and adhesive	Strong presumption (extrapolation)	5SM	NA	0	0	1	2	NA	NA	Remove	30/05/18		Tiles contaminated by adhesive	No

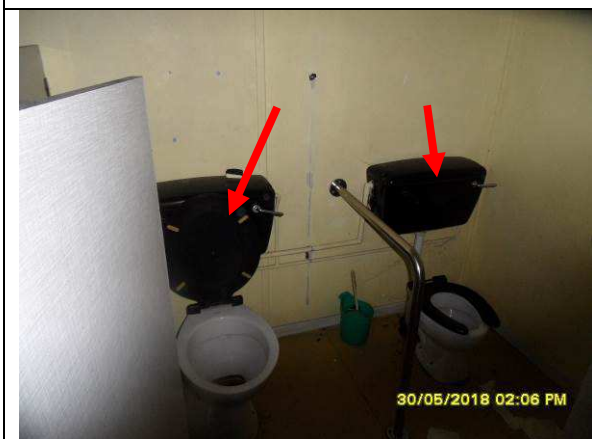
9462AS – 014

B	9462 AS-001			9462AS-014	G17	Wall mounted	Toilet cistern	Reinforced plastic and resin composites	Strong presumption (extrapolation)	4No	NA	1	0	1	3	NA	NA	Remove	30/05/18			No
B	9462 AS-001			9462AS-015	G18	Wall mounted	Toilet cistern	Reinforced plastic and resin composites	Strong presumption (extrapolation)	2No	NA	1	0	1	3	NA	NA	Remove	30/05/18			No
B	9462 AS-002			9462AS-019	G32 and G33	Flue from burner through roof	Flue pipe	Cement - Pre-formed moulded or extruded products	Strong presumption (extrapolation)	2LM	NA	1	1	3	6	NA	NA	Remove	30/05/18			No*
B	9462 AS-003			9462AS-020	G32 and G33	Bunny burner internals	Lining board	Cement - Fully comp flat sheet, tiles, slates & boards	Strong presumption (extrapolation)	1No	NA	1	1	3	6	NA	NA	Remove	30/05/18			No*
B	9462 AS-002			9462AS-022	G12	Flue from burner through roof	Flue pipe	Cement - Pre-formed moulded or extruded products	Strong presumption (extrapolation)	2LM	NA	1	1	1	4	NA	NA	Remove	30/05/18			No*

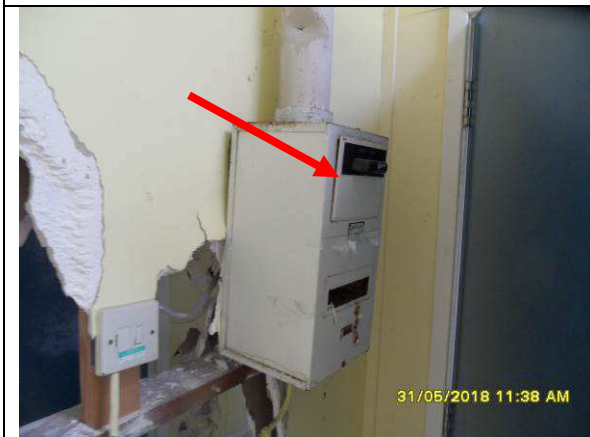
9462AS – 023

B	9462 AS-003			9462AS-023	G12	Bunny burner internals	Lining board	Cement - Fully comp flat sheet, tiles, slates & boards	Strong presumption (extrapolation)	1No	NA	1	1	1	4	NA	NA	Remove	30/05/18			No*
B	9462 AS-001			9462AS-024	G12	Debris to floor	Toilet cistern	Reinforced plastic and resin composites	Strong presumption (extrapolation)	Small Quants	NA	1	0	1	3	NA	NA	Remove	30/05/18			No
B	9462 AS-025			9462AS-027	G30, G31 and G33	Bitumen to screed under vinyl	Bitumen adhesive	Bitumen adhesive & paints	Strong presumption (extrapolation)	11SM	NA	0	0	1	2	NA	NA	Remove	30/05/18		Vinyl is contaminated	No
G			PHH62-02-4	9462AS-004	G01	Underside of loose sink	Bitumen pad	Bitumen coatings on metal	Negative asbestos sample	1No	NA	NA	NA	NA	NA	NA	NA	No action not an ACM	30/05/18			
G			PHH62-02-11	9462AS-016	G32 and G33	To floor across threshold	Brown tiles and adhesive	PVC vinyl flooring and adhesive	Negative asbestos sample	2LM	NA	NA	NA	NA	NA	NA	NA	No action not an ACM	30/05/18
