**Geotechnical & Geo-environmental Site
Investigation Report:**

Proposed Residential Development,
Former Infant School
Brodog Lane
Fishguard
SA65 9NR

Report No. 14542

REPORT TITLE : **Geotechnical and Geoenvironmental Report Site Investigation Report:**
Proposed Residential Development, Former Infant School Site, Brodog Lane, Fishguard, SA65 9NR

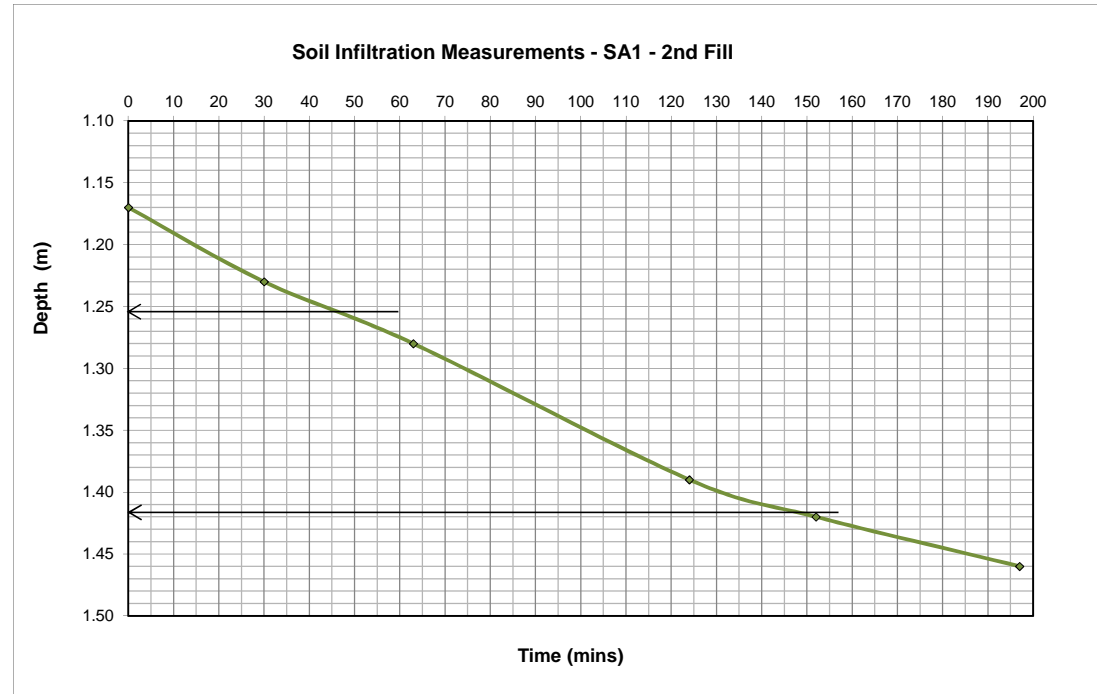
Length of Trial Pit (m)	1.70	
Width of Trial Pit (m)	0.50	
Depth of Trial Pit (m)	1.50	
Effective Storage Depth (m)	0.33	
Vp25	1.2525	
Vp75	1.4175	
Vp75-25	0.140	
Outflow (%)	88	
50% effective depth (m)	0.165	
Mean Surface area ap50 (m2)	1.576	
Time for 25% Outflow (tp25)	45	From Graph
Time for 75% Outflow (tp75)	143	From Graph
tp75 - 25	98	
Soil Infiltration Rate (m/s)	1.51345E-05

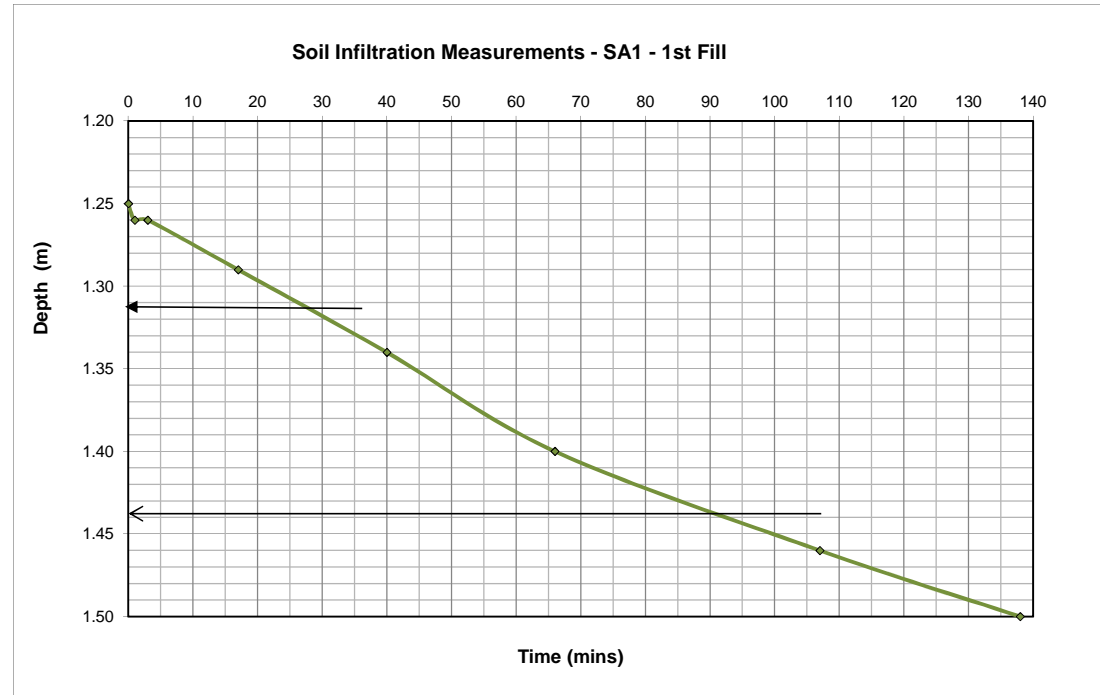
Depth to Water (m)	Time (Mins)
(effective depth - 100%)	1.25	0
	1.26	1
	1.26	3
	1.29	17
	1.34	40
	1.40	66
	1.46	107
(effective depth - 0%)	1.50	138
Length of Trial Pit (m)	1.70	
Width of Trial Pit (m)	0.50	
Depth of Trial Pit (m)	1.50	
Effective Storage Depth (m)	0.25	
Vp25	1.3125	
Vp75	1.4375	
Vp75-25	0.106	
Outflow (%)	100	
50% effective depth (m)	0.125	
Mean Surface area ap50 (m2)	1.400	
Time for 25% Outflow (tp25)	27	From Graph
Time for 75% Outflow (tp75)	92	From Graph
tp75 - 25	65	
Soil Infiltration Rate (m/s)	1.94597E-05

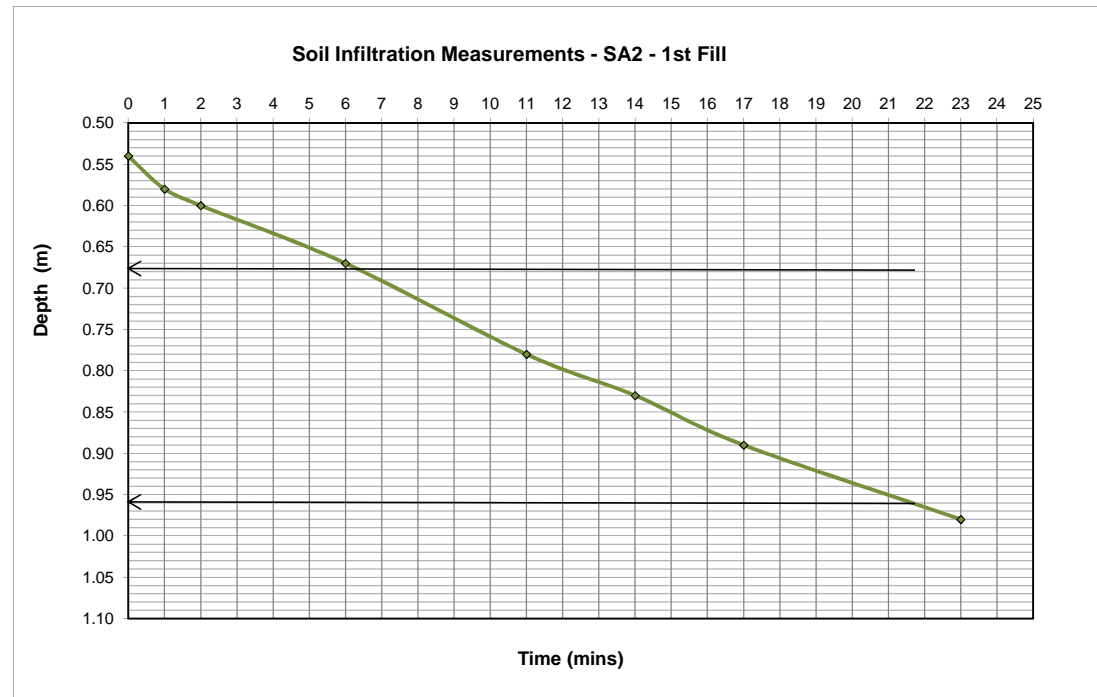
Depth to Water (m)	Time (Mins)
(effective depth - 100%)	0.54	0
	0.58	1
	0.60	2
	0.67	6
	0.78	11
	0.83	14
	0.89	17
(effective depth - 0%)	0.98	23
Length of Trial Pit (m)	1.50	
Width of Trial Pit (m)	0.50	
Depth of Trial Pit (m)	1.10	
Effective Storage Depth (m)	0.56	
Vp25	0.6800	
Vp75	0.9600	
Vp75-25	0.210	
Outflow (%)	79	
50% effective depth (m)	0.280	
Mean Surface area ap50 (m2)	1.870	
Time for 25% Outflow (tp25)	6.5	From Graph
Time for 75% Outflow (tp75)	21.5	From Graph
tp75 - 25	15	
Soil Infiltration Rate (m/s)	0.000124777

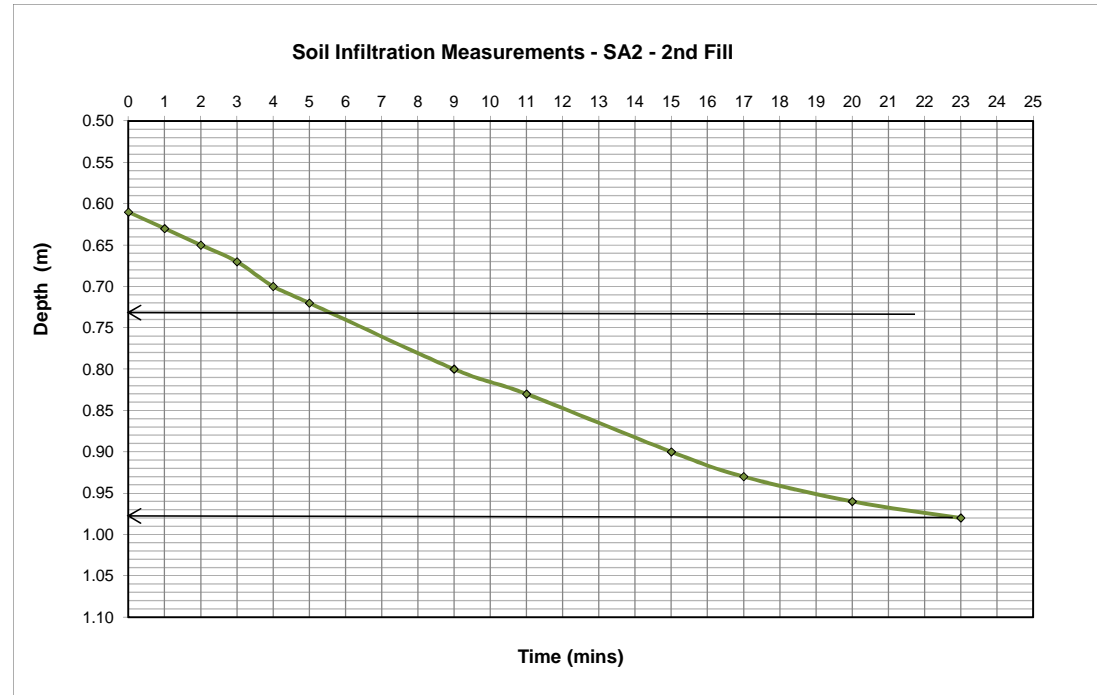
Time for 25% Outflow (tp25)	5.5	From Graph
Time for 75% Outflow (tp75)	22.5	From Graph
tp75 - 25	17	
Soil Infiltration Rate (m/s)	0.000104131

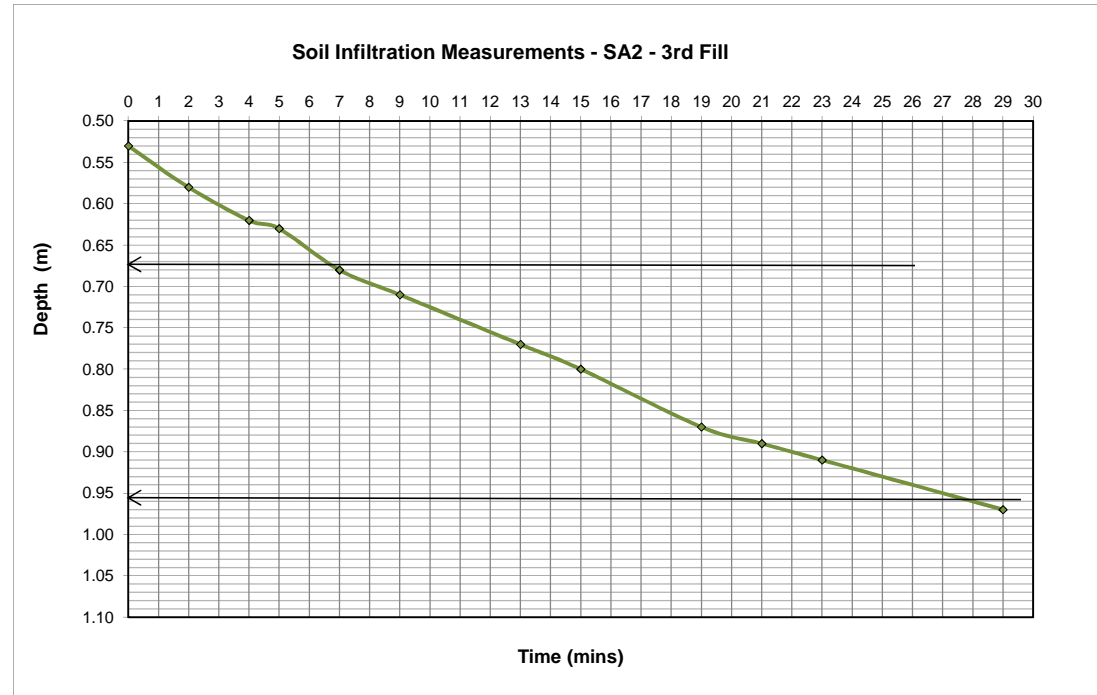
Time for 25% Outflow (tp25)	6.75	From Graph
Time for 75% Outflow (tp75)	27.5	From Graph
tp75 - 25	20.75	
Soil Infiltration Rate (m/s)	9.08395E-05
