# PARC MAEN HIR, LETTERSTON, PEMBROKESHIRE: HISTORIC ENVIRONMENT APPRAISAL UPDATE

Prepared by Dyfed Archaeological Trust  
For: Ateb Group

RHIF YR ADRODDIAD / REPORT NO. 2019/26  
RHIF YR DIGWYDDIAD / PROJECT NO. 118019

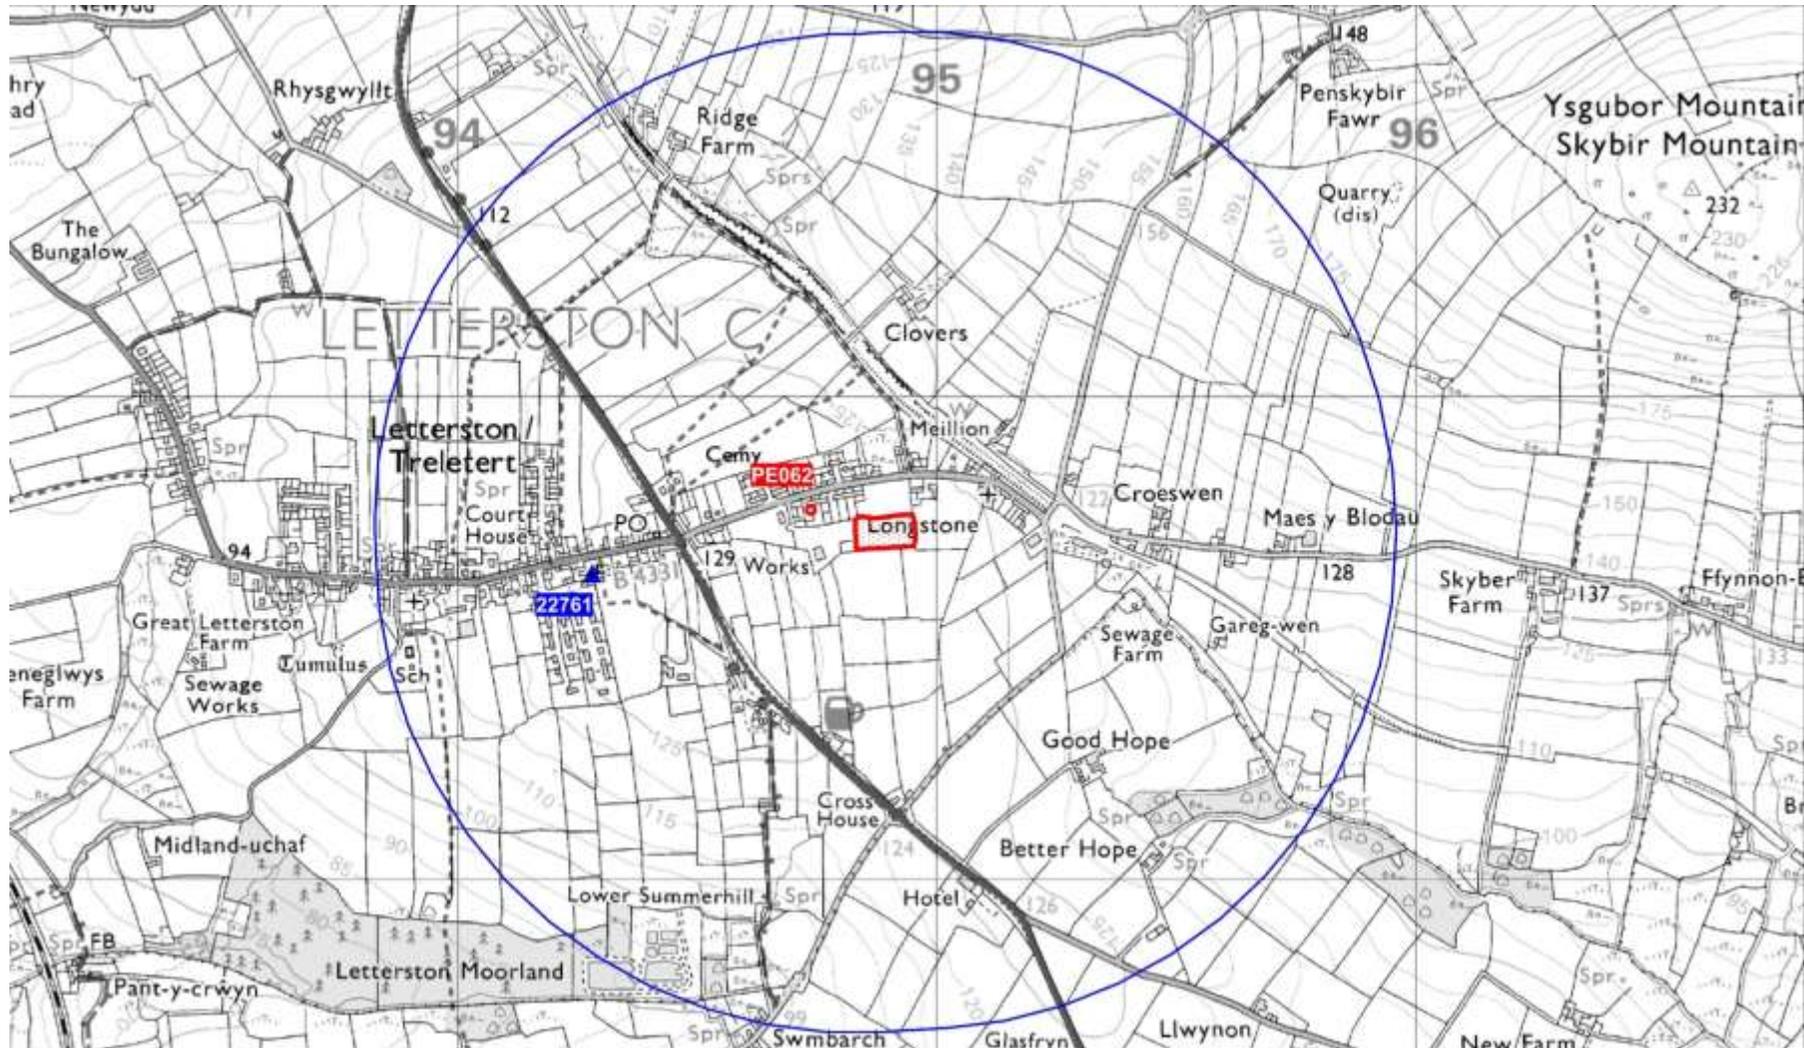
**Figure 2:** The Pen Dre round barrow Scheduled Monument PE062 and Saron Baptist Chapel grade II listed building (reference 22761) with the proposed Phase 2 development area in red

- 3.3.2 There is limited intervisibility between the scheduled barrow site and the development area, with vegetation, built environment, fences etc blocking any clear views. Additional screening through vegetation planting and appropriate fencing boundaries would mitigate for any further negative impacts on the setting of the monument.

- 3.4.1 There is one Listed Buildings within 1km of the development area, that of Saron Baptist Chapel (reference 22761) some 550m west of the development area on the western side of the A40. The building is dated to 1869. There is no intervisibility between the listed building and the development site.

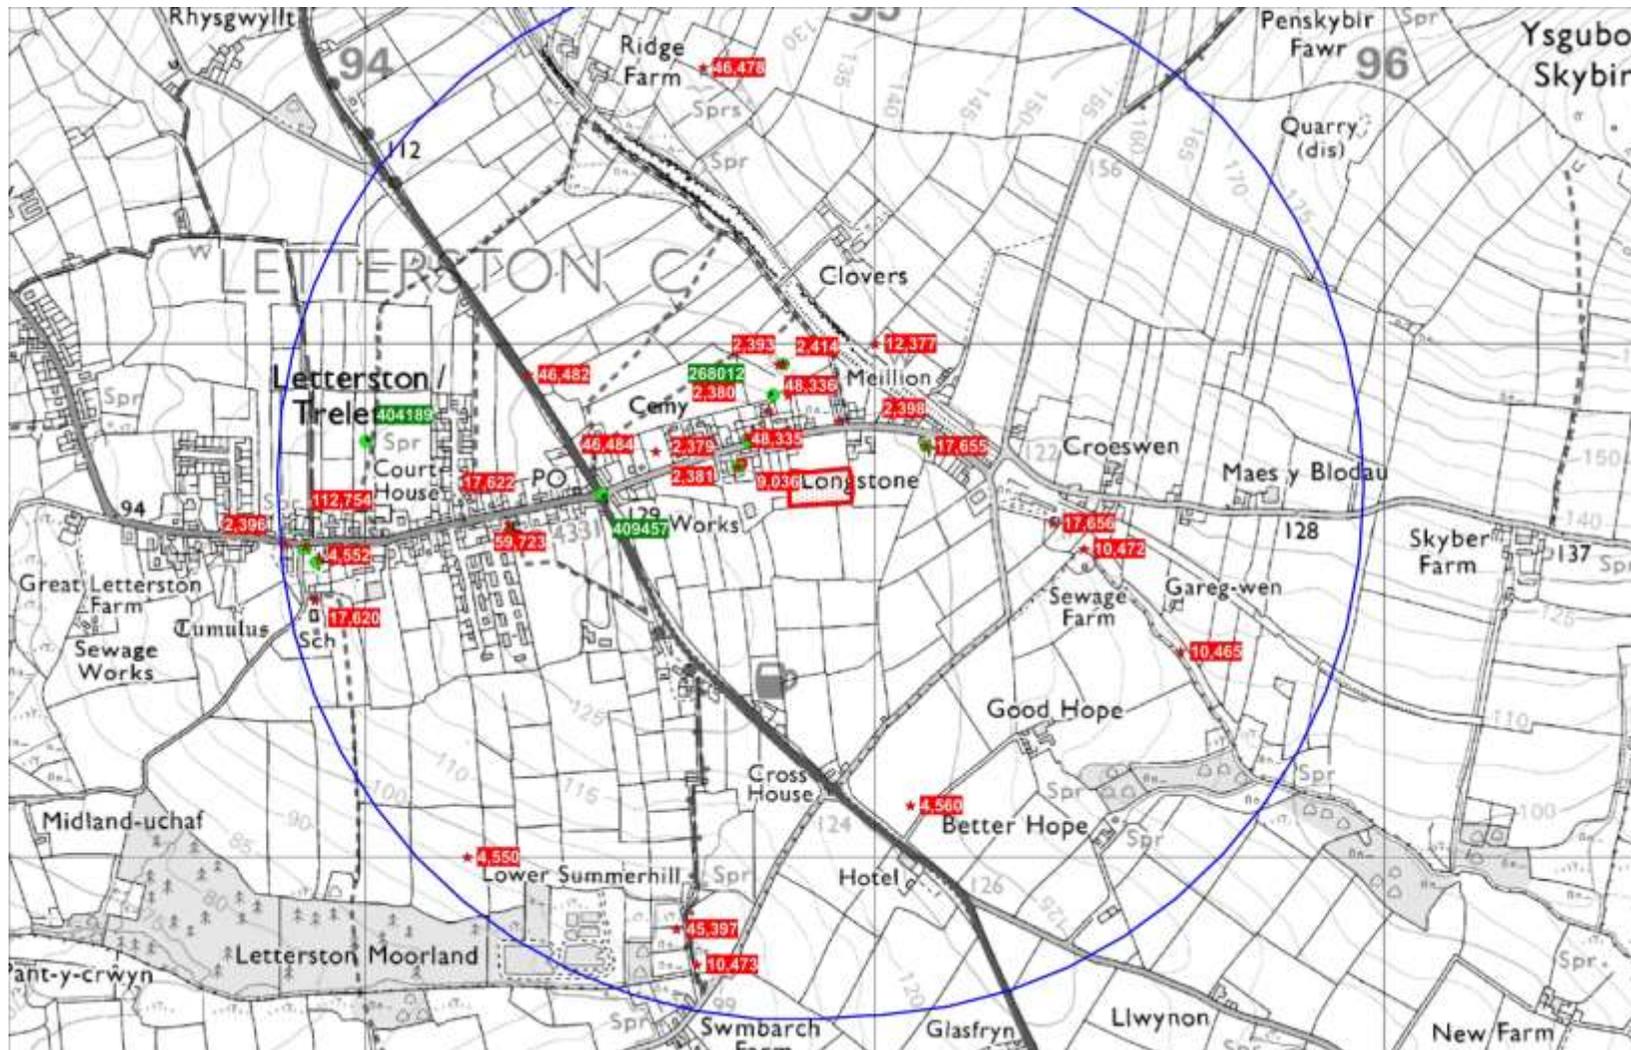
**Figure 3:** Map showing heritage assets recorded on the HER (red) and NMR (green) within 1km of the proposed development site (only NMR sites not recorded on the HER area shown)

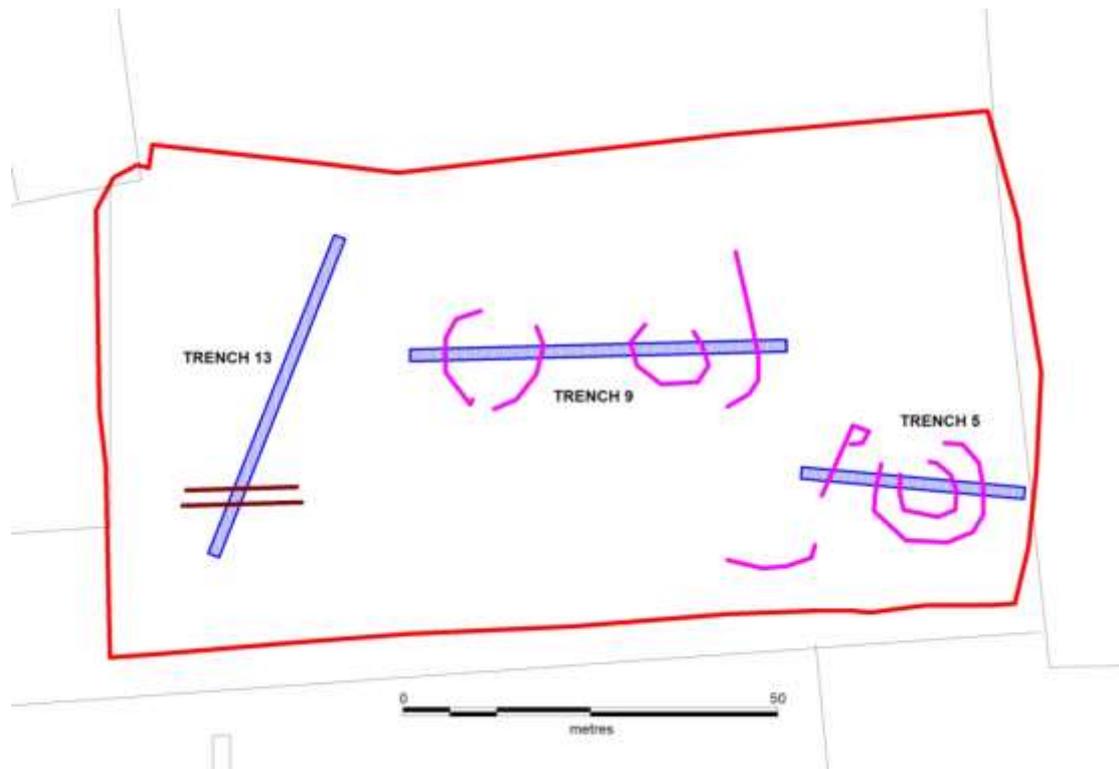
**Figure 4:** Approximation of the three trenches opened by BARAS in 2009 within the Phase 2 area of the Parc Maen Hir development showing geophysical survey anomalies targeted (pink) and field boundary recorded in Trench 13 (brown)

- 3.6.5 Trench 5 was located in the southeastern corner of the Phase 2 area targeting a possible double concentric ringed feature and a further linear anomaly. It was 30m in length orientated east to west. No sign of the geophysical anomalies were noted.

- 3.6.6 Trench 9 was aligned east to west in the top middle part of this study site area targeting two possible circular anomalies and a further linear feature seen on the geophysical survey. It measured 50m long and 1.8m in width. One of the possible curvilinear features was observed as a change in the natural geology which was confirmed on excavation.

- 3.6.7 Trench 13 ran roughly north-northeast to south-southwest on the western side of the area 46m in length. Two parallel linear features were observed, roughly orientated east to west crossing the trench. The first was 1.23m wide, 2.15m length visible and 0.12m deep and the second 1m wide, 2.2m long and 0.08m deep. They were positioned 1.9m apart separated by bare clay subsoil and were thought to represent a former hedge boundary. These were the only features confirmed within the evaluation.

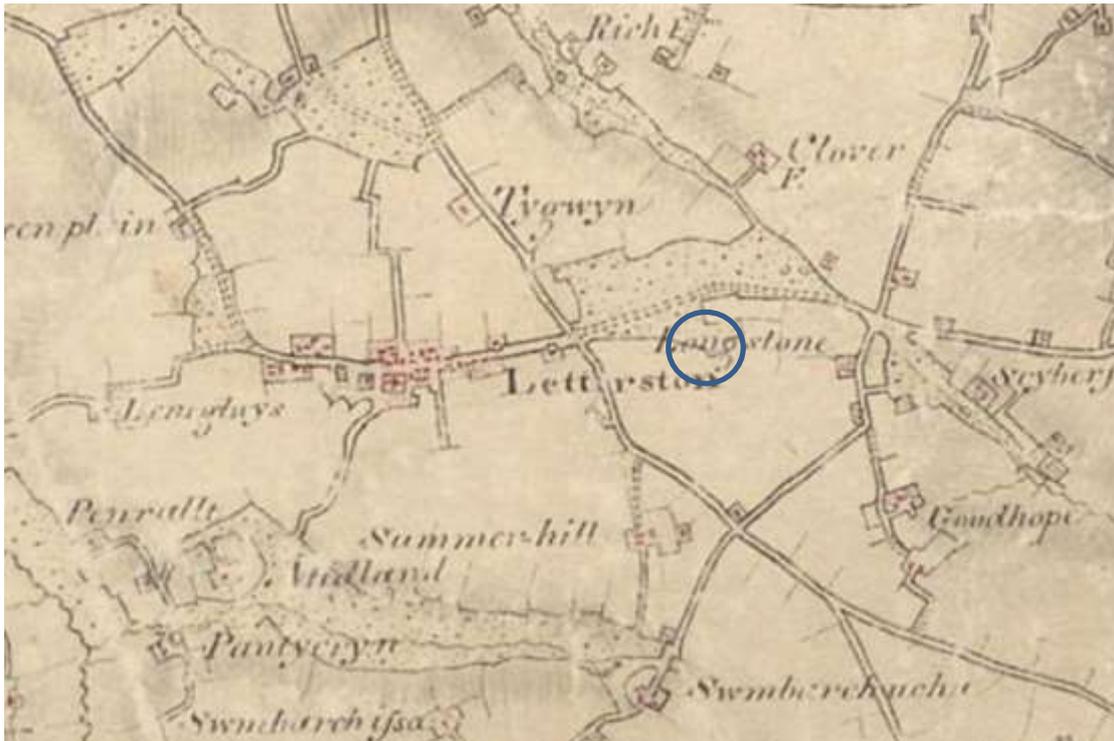
**Figure 5:** Extract of the 1811 original survey drawing (Fishguard) of Letterston, with the approximate position of the proposed development site circled in blue

- 3.9.1 The original Ordnance Survey (OS) drawing of 1811 of the Fishguard area is the earliest available map for Letterston to show any great detail of the village and its surroundings (Figure 5). The proposed development site is shown simply as farmland on the eastern side of the main road through the village. It is labelled as Longstone but no further detail is visible. Station road at this time is indicated as a track.

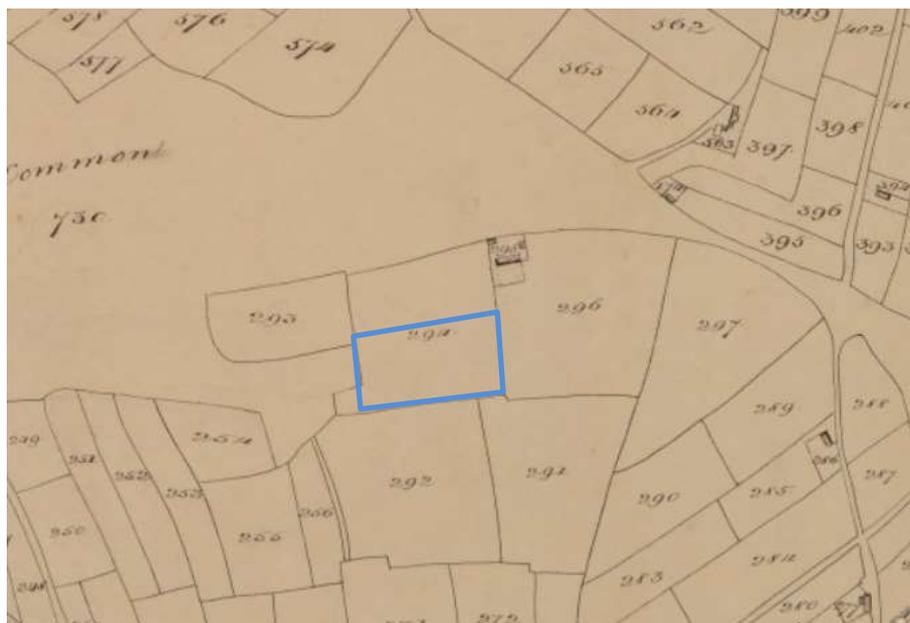
**Figure 6:** Extract of the 1841 Letterston Tith Map, with the approximate position of the proposed development site outlined in blue

3.9.2 The Letterston Tith Map of 1841 (Figure 6) shows more detail than the 1811 OS map, and includes buildings for Longstone Farm and two enclosed fields around it. The Phase 2 part of the Parc Maen Hir development occupies the southern half of one of these fields. The field name is recorded as Parc y Ffynt (possibly translated as Stream Park). The main development area of Letterston lies to the west of the main north south road. Station Road is not shown, the area forming part of Letterston Common.

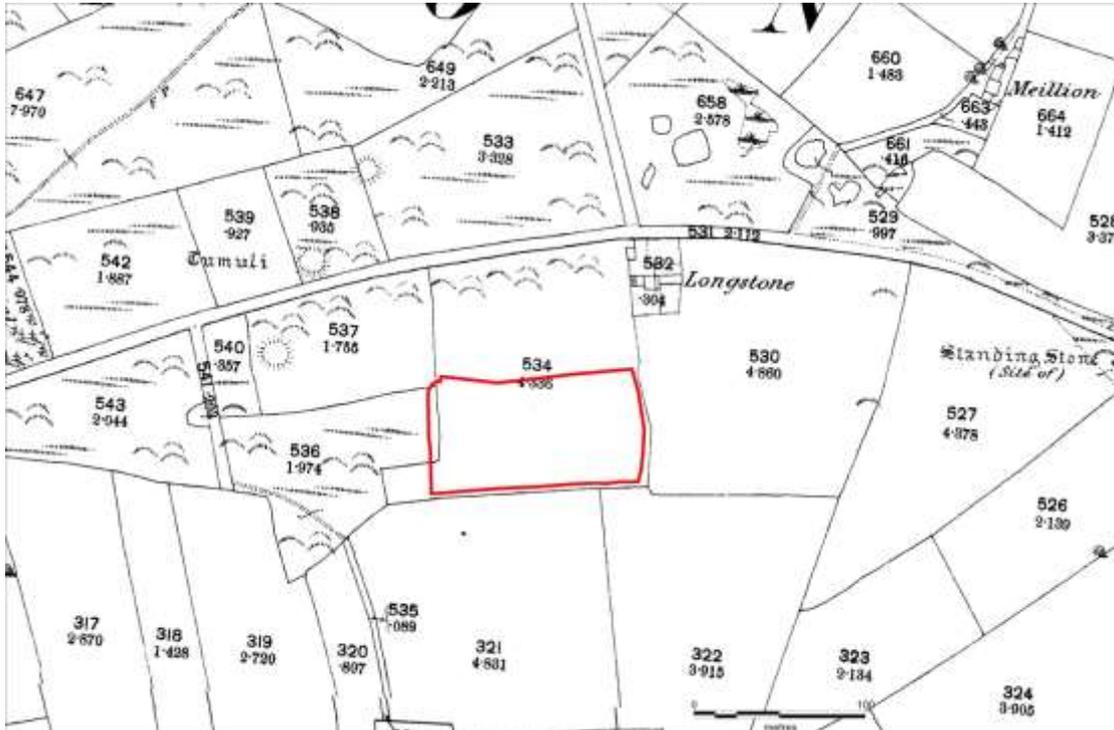
**Figure 7:** Extract of the 1889 Ordnance Survey 6 inch to 1 mile map, with the proposed development site outlined in red.

3.9.3 Detailed maps of the site were surveyed by the OS in around 1889, and published in 6 inch to 1 mile form. The map (Figure 7) shows little change to that of the Tithe Map, although more detail is provided and by this time Station Road has been clearly laid out. Longstone Farm is clearly shown. The three round barrows are shown on the map to the west/northwest of the site area, labelled as Tumuli and in a linear arrangement. No other properties are present along Station Road.

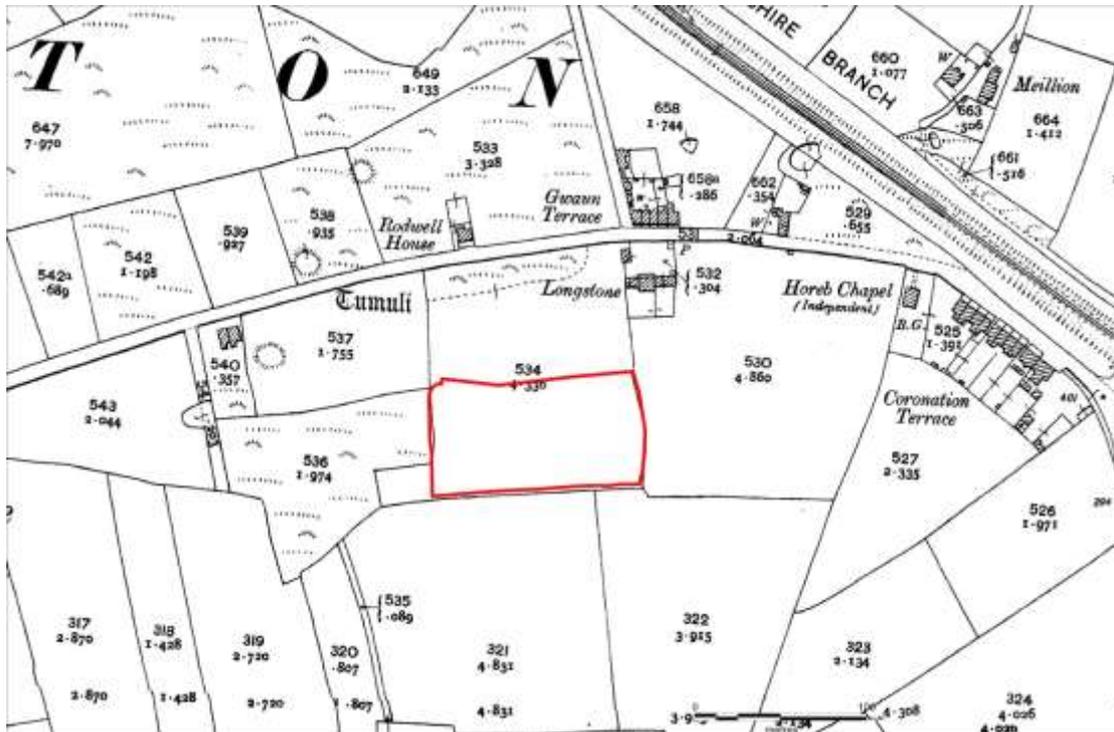
**Figure 8:** Extract of the 1907 Ordnance Survey 6 inch to 1 mile map, with the proposed development site outlined in red.

3.9.4 The 1907 1: 2500 scale map of Letterston (Figure 8) shows the start of development on the northern side of the road, but otherwise is almost identical to that of the 1889 map.

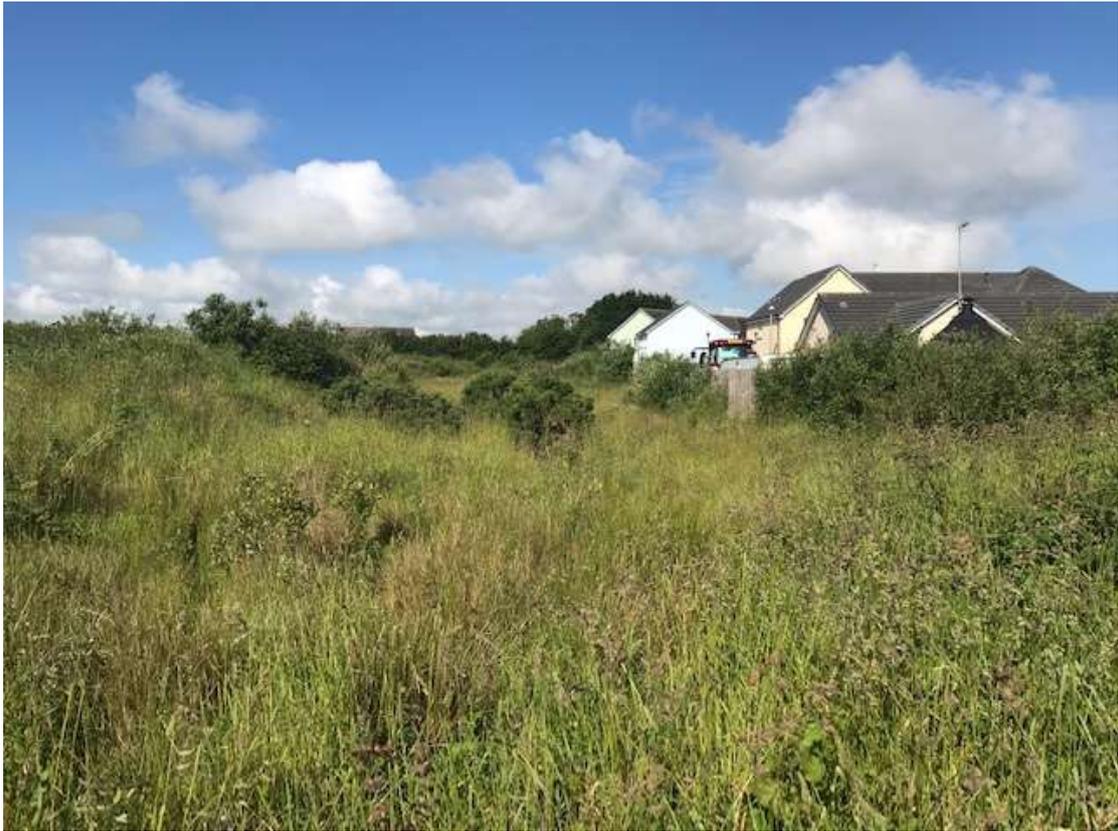
**Photo 1:** View west along the southern part of the Phase 2 development area, with the fenced off Parc Maen Hir development to the north (right)

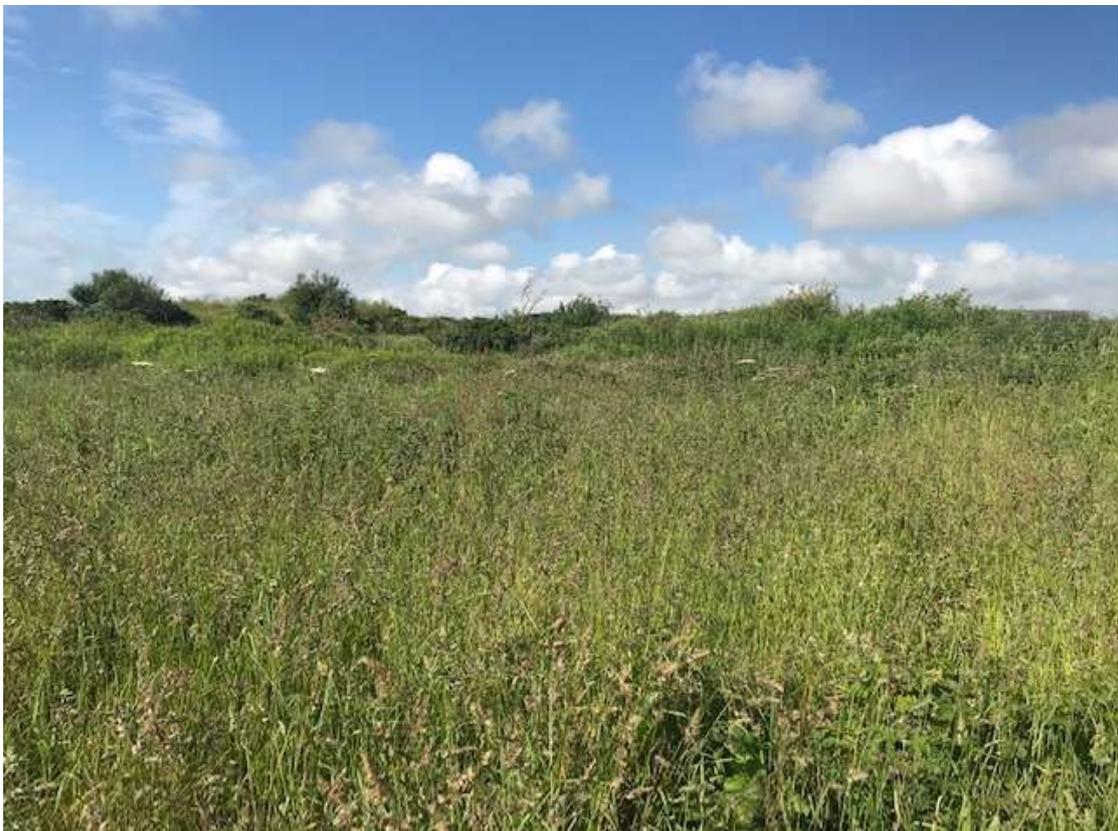
**Photo 2:** View southwest across the Phase 2 area showing the overgrown nature of the site with the rise of spoil heaps visible

3.10.4 It was clear that spoil heaps were still present in the Phase 2 area, now very overgrown. A number of excavated channels were also noted as well as deep ruts from vehicle tracking much of which may have occurred when the adjacent development was ongoing. Nowhere within the site area were there any larger areas of untouched ground.

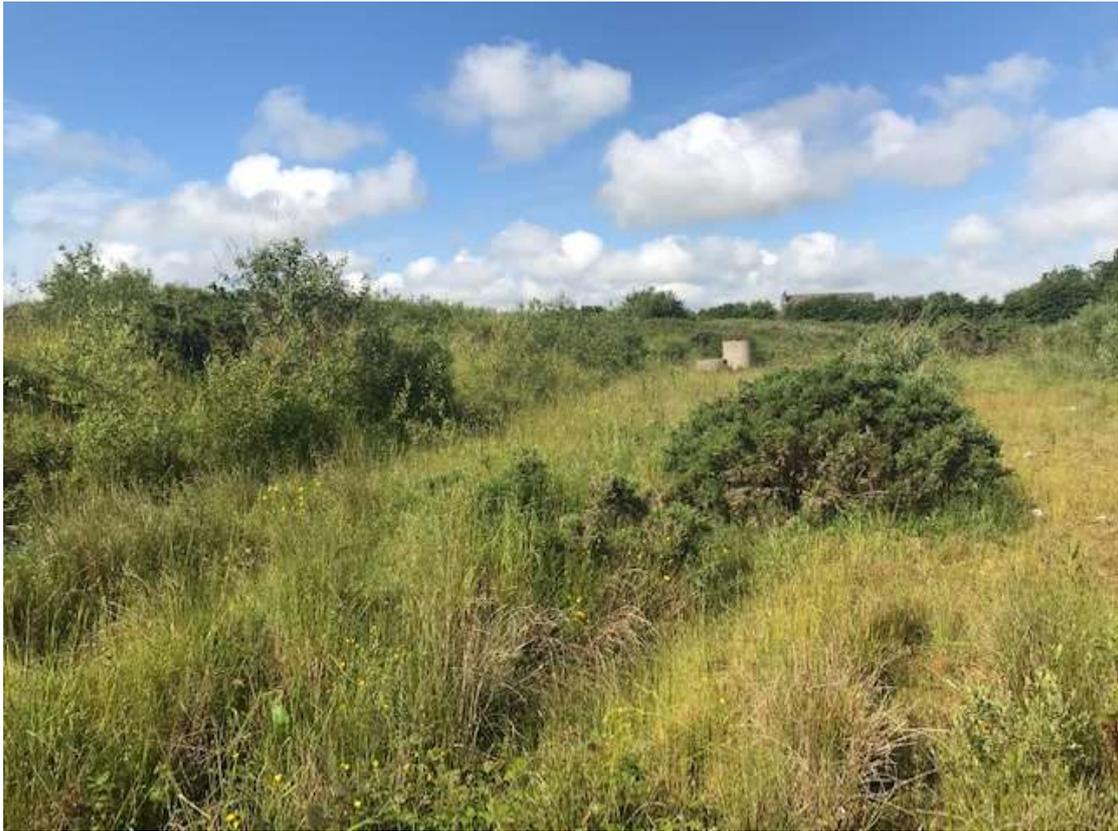
**Photo 3:** View west along the base of a spoil heap where a deeper channel was still visible containing concrete inspection chamber pieces

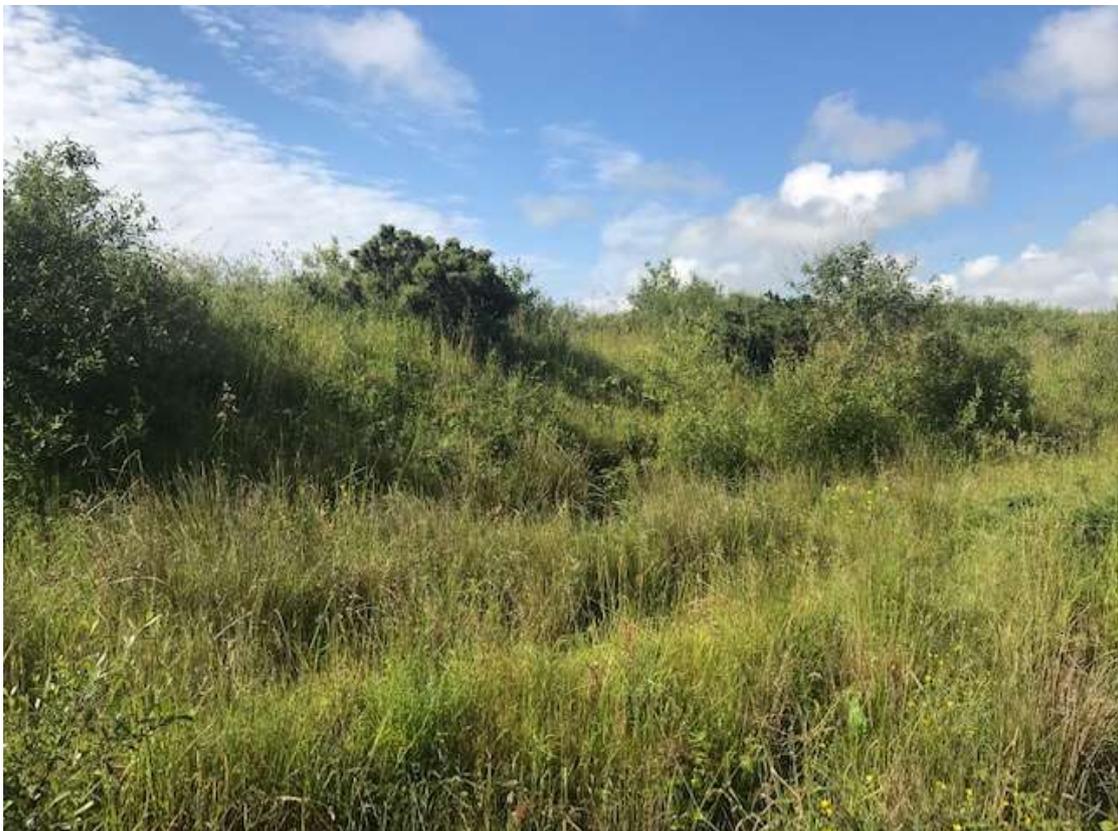
**Photo 4:** View southwest in centre of development area showing raised linear spoil heap with wheel ruts still visible in the long grass in front of it

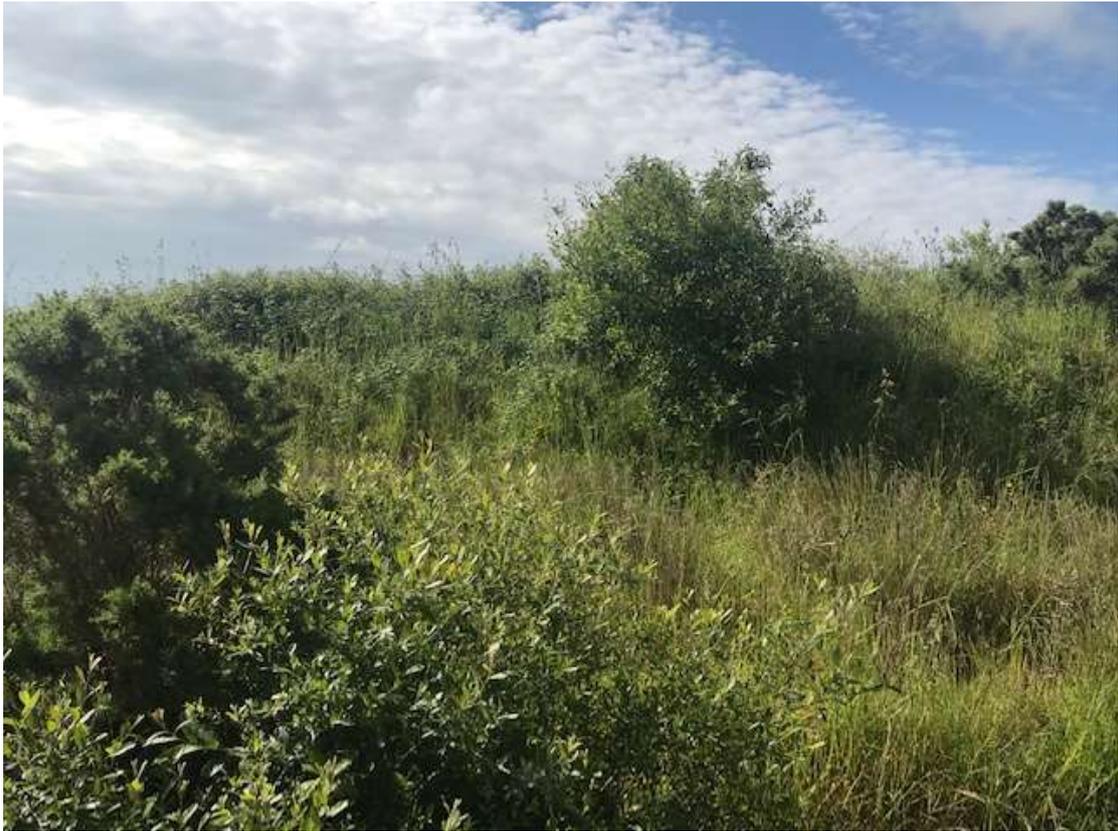
**Photo 5:** View south in centre of development area showing rise of spoil heap and vegetation growth on top
